Water Compliance Inspection Report

Water/NPDES Compliance Inspection Report

NPDES Permit No. DC0000019

**Department of the Army, Baltimore District,
Corps of Engineers, Washington Aqueduct Division
Washington, DC.**

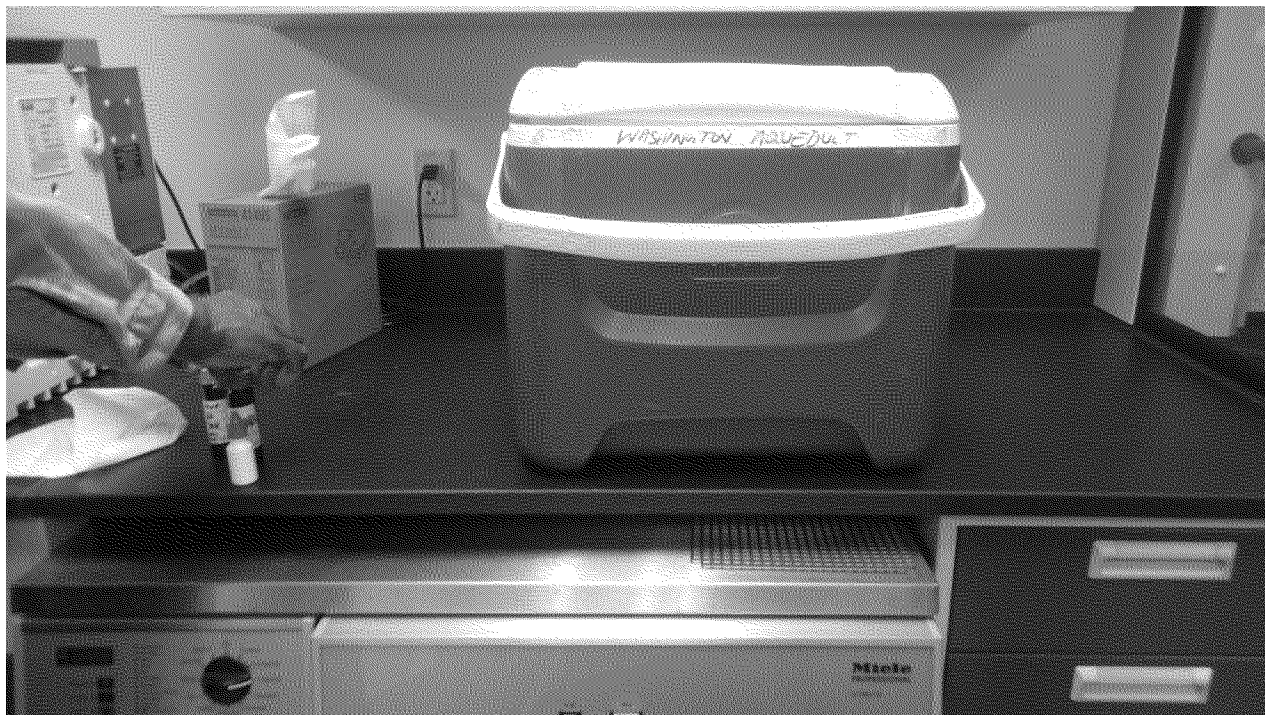
Raw and processed waters are monitored at different stages of the treatment process. Samples are collected (**Photo 8**), stored (**Photo 9**), and processed according to the permit requirements.

Photo 8: Sampling technician preparing field blanks and the cooler use for preservation during sample transportation.

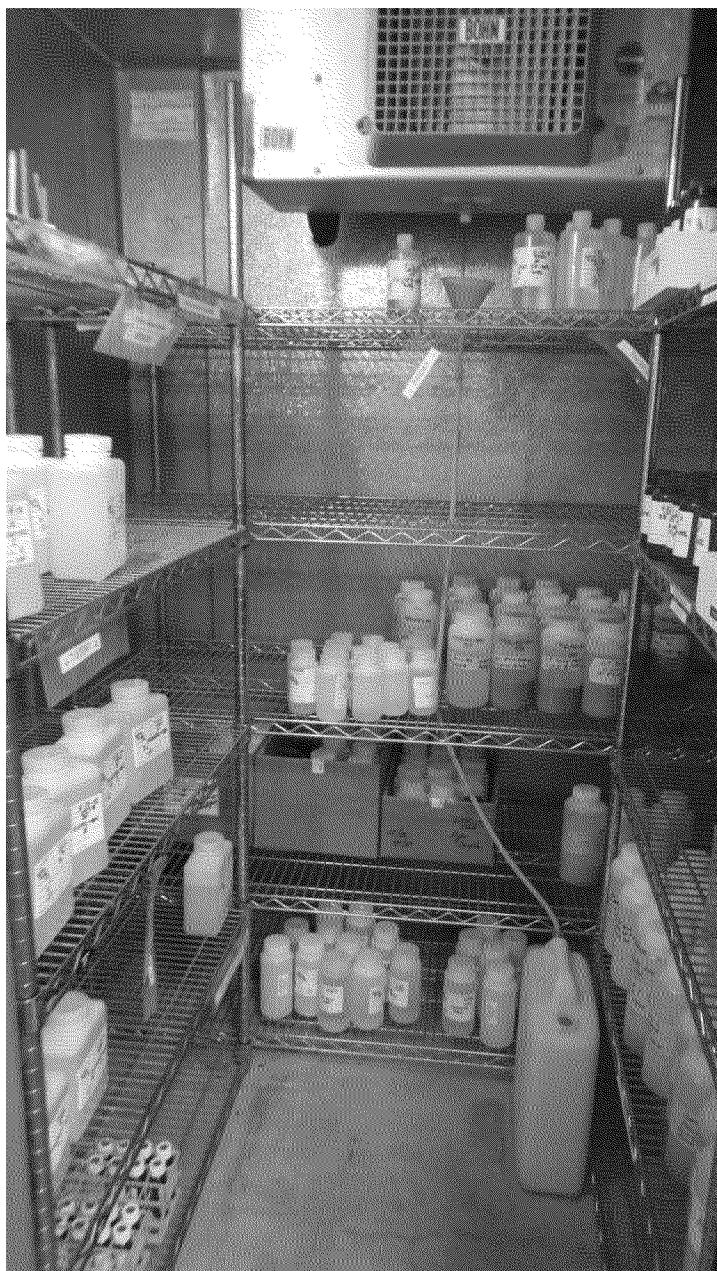
Photo 9: Sample storage cooler where samples are kept prior to processing.

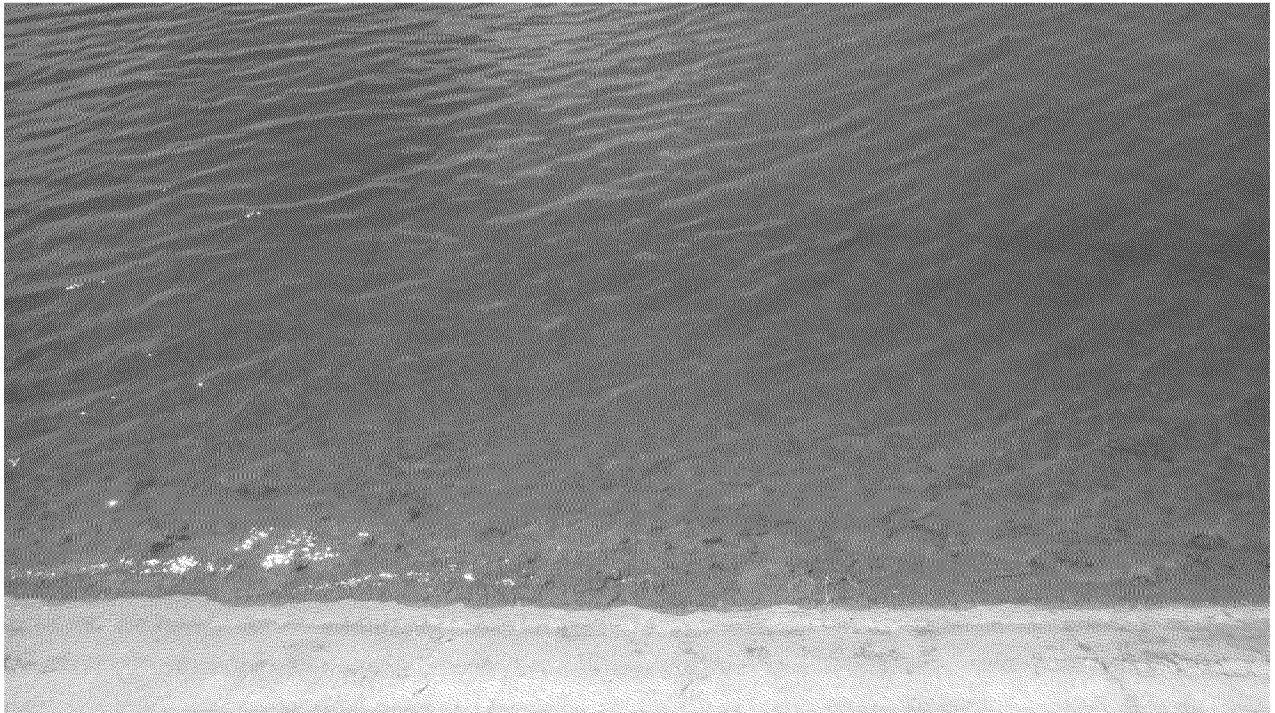
- The deficiencies with the sediment removal in the Georgetown Basins have not been resolved and sediment has begun accumulating in Georgetown Sedimentation Basin #2 **(Photo 15)**.

Photo 15: Six months after the 2014 bypass and basin cleaning sediments have begun to accumulate on the floor of Georgetown Sedimentation Basin #2.

- A clear plan to prevent future bypasses could not be provided; however, senior facility representatives stated that only under the circumstances of a “catastrophic failure” would a discharge from the Georgetown Sedimentation Basin occur. Other methods of sediment removal would be utilized and a discharge would only be considered as a last option. Currently, the engineering firm that designed and installed the sediment removal barges have been placed on contract and are currently troubleshooting the system.
